Manhole Inspection Summary

Manhole # S47CC_053MH

Location Address: **COLLINGTON-DUNCAN**

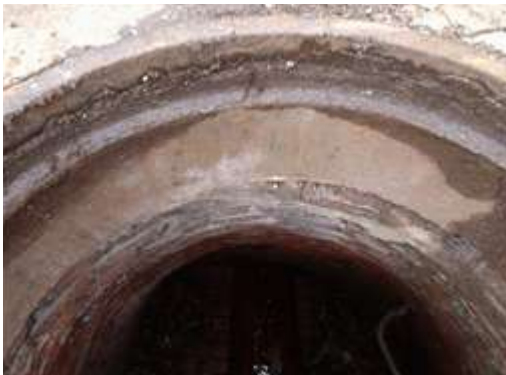
Defect 2

Frame Offset: **0** (in.) Condition: ☐ Sound ☐ Cracked ☒ **Leaks**

Frame Leaks

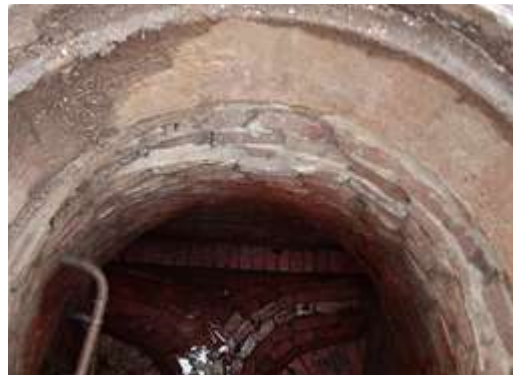
Defect 1

Condition: ☐ Sound ☐ Cracked ☐ Root Intrusion ☐ Loose Brick ☒ **Deteriorated**

Infiltration: ☐ None ☐ Joint ☐ Cracks ☒ **Mortar** ☐ Roots ☐ Wall

Deterioration

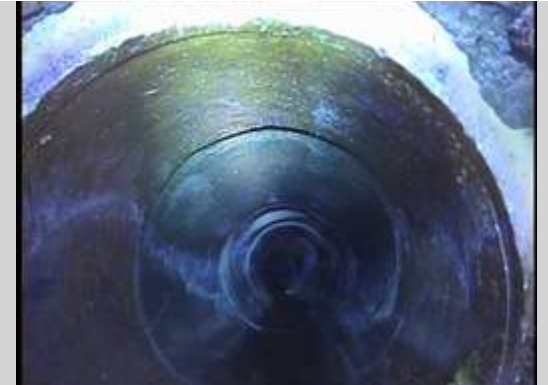
12 O'Clock Outflow

12 in. Circular Gravity Sewer
Pipe Out @ 12 O'Clock

Pipe Height: **9.6** (in.) Rod and Bar (Angled)
Pipe Material: **Clay** ☐ Pipe Lined
Invert Depth: **9.70** (ft.) Flow Characteristics: **Slow**
Deposits: ☒ None ☐ Mud ☐ Sludge ☐ Debris ☐ Grease
Silt Depth: (in.) Deposits Extent:
Infiltration: **None** Pipe Seal Cond: **Sound**

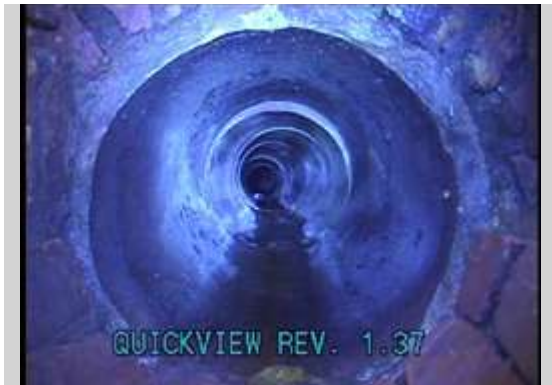
3 O'Clock Inflow

10 in. Circular Gravity Sewer
Pipe In @ 3 O'Clock

Pipe Height: **9.6** (in.) Rod and Bar (Angled)
Pipe Material: **Clay** ☐ Pipe Lined
Invert Depth: **9.60** (ft.) Flow Characteristics: **Slow**
Deposits: ☒ None ☐ Mud ☐ Sludge ☐ Debris ☐ Grease
Silt Depth: (in.) Deposits Extent:
Infiltration: **None** Pipe Seal Cond: **Sound**

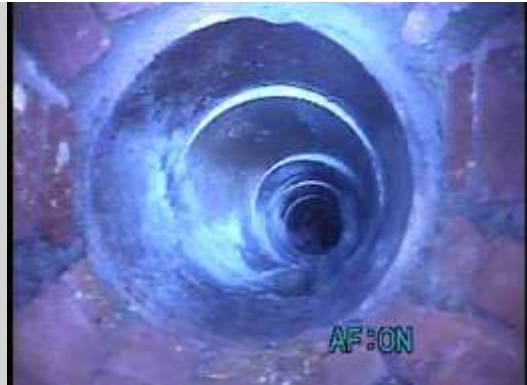
9 O'Clock Inflow

10 in. Circular Gravity Sewer

Pipe In @ 9 O'Clock

Pipe Height: **9.6** (in.) Rod and Bar (Angled)

Pipe Material: **Clay** ☐ Pipe Lined

Invert Depth: **8.50** (ft.) Flow Characteristics: **None**

Infiltration: **None** Pipe Seal Cond: **Sound**
